# Ductile cast iron inserts for spent nuclear fuel disposal: radiography and fractography

F. Lofaj<sup>1,2\*</sup>, L. Metten<sup>1</sup>, A. van de Sande<sup>1</sup>, K.-F. Nilsson<sup>1</sup>, A. Eriksson<sup>1</sup>

<sup>1</sup>Joint Research Centre – EC, Institute for Energy, P.O. Box 2, 1755 ZG Petten, The Netherlands

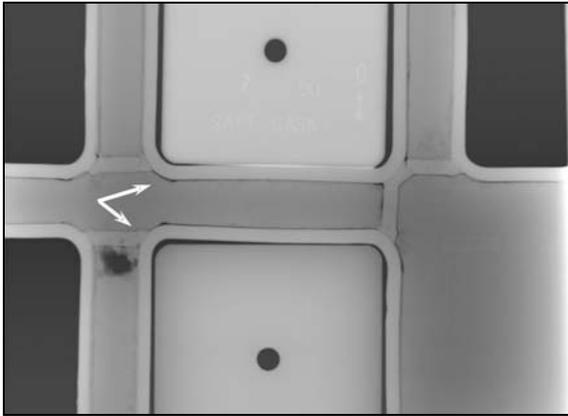
**As-produced insert:** Both slices from I26 insert, 50 mm and 200 mm thick were examined in axial direction. The results from a 50 mm slice are shown in Fig. 5 and Fig. 6. The largest defects include casting blowholes and/or their clusters adjacent to the steel channel bridging strips and debonding between the matrix and steel channels (see arrows in Fig. 5). The size of blowhole indicated between the channels is almost 17 mm. It seems to be one hole rather than agglomerate of several holes formed near the insert during casting. Debonding between the matrix and steel tubes is relatively often visible around the corners of the channels. Figure 6a shows several dark indications scattered in the bulk and individual indications and their agglomerates near the channel surfaces. Note the indications from 6 FE DIN IQI wire penetrameter in the center of this figure. The thinnest wire visible on the film was the wire No. 10 with the diameter of 0.40 mm. Thus, the radiographic sensitivity in this case corresponds to 0.8 %, which is considerably better than 2 % limit used in industry.

Fig. 5. Large blowholes adjacent to the bridging strip fixing neighboring steel and partial debonding between the tubes and cast iron (see arrows) are visible in 50 mm slice of I26 insert examined in axial direction.

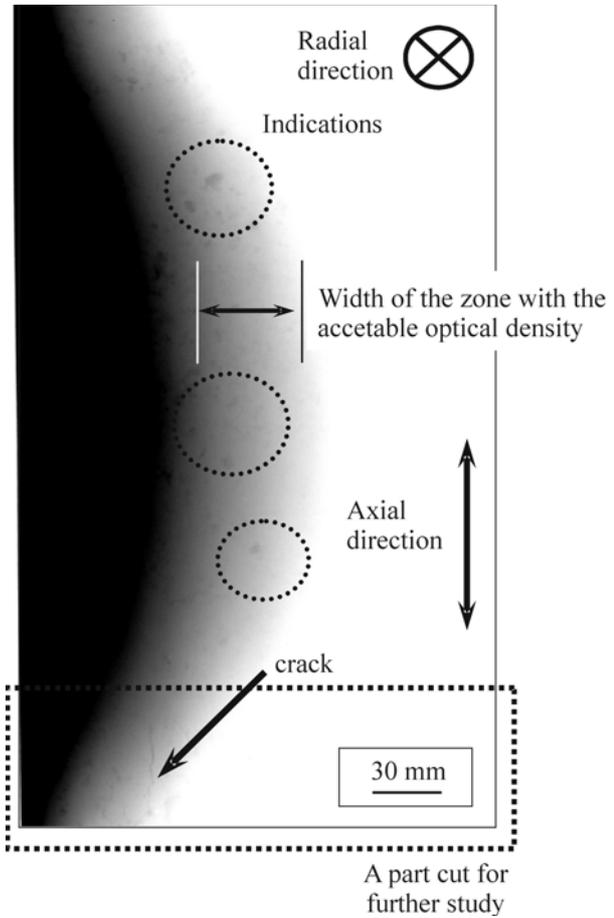
Fig. 7. Radiographic image of the side wall of L1 segment from the mock-up with large cracks in radial direction. The zone with the largest crack in the dotted box was cut for further studies (see Figs. 8 and 9). The variation in wall thickness causes that only a narrow zone in the radiograph exhibits optical density of 2.3–3.5 D, which is suitable for the inspection.

The segment L1 with the largest cracks was chosen for further study. An approximately 50 mm thick part with cracks (the box in Fig. 7) was cut from L1. The obtained segment is shown in Fig. 3 and the zone of outside wall in the box was studied in axial direction. Both top and bottom sides of this slice were subsequently ground to prevent overlapping of surface roughness with the internal defects. Figure 8 shows radiographic image of this piece in axial direction. Optical density of the films is approxim-

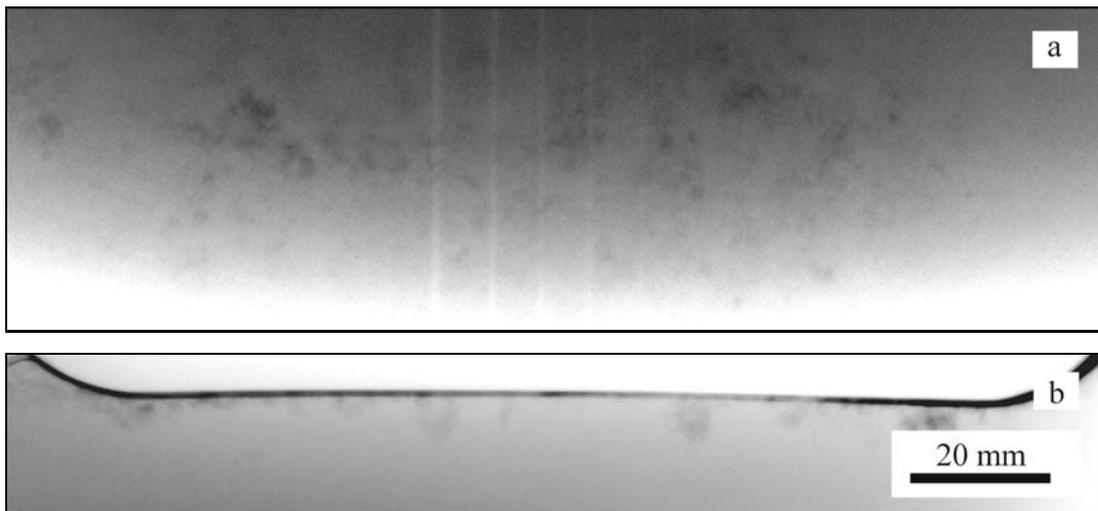
Figure 6b shows similar indications along channel surface at the interface with steel tube. The examination of 200 mm thick slice revealed principally the same defects – blowholes, debonding and inclusions, however, the contrast was considerably lower. The largest blowholes observed were around 10 mm in diameter.

Fig. 6. a) The indications (dark spots) in the bulk of the cast iron; the wire penetrameter was put on the sample; b) the inclusions along the interface with the steel tube.

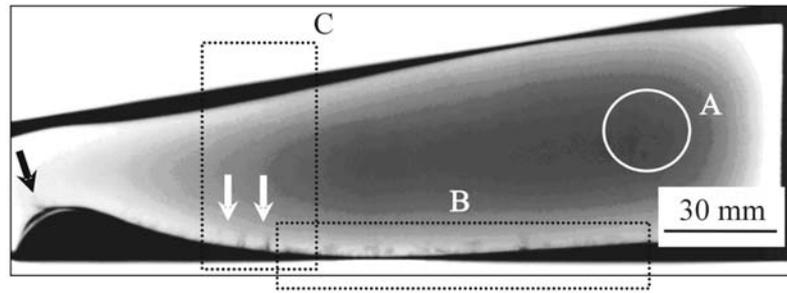
Fig. 8. Radiographic image of the area indicated in Fig. 3 in axial direction revealed clusters of inclusions (A), multiple inclusions along the inner surface (box B), large cracks at the inner surface (box C with two arrows) and additional cracks at the channel corner (arrow). The zone C corresponds to the zone with the cracks in Fig. 7.

ately constant due to constant thickness of the slice. At least two cracks near the inner surface of the insert wall (see two arrows) were found besides relatively large indications in the bulk of the wall (A), numerous smaller indications under the inner surface (box B) and another crack in the corner of the channel (see arrow). Cracks in the insert wall seem to result from the pressure test, because they were never observed in the walls of the as-produced inserts.

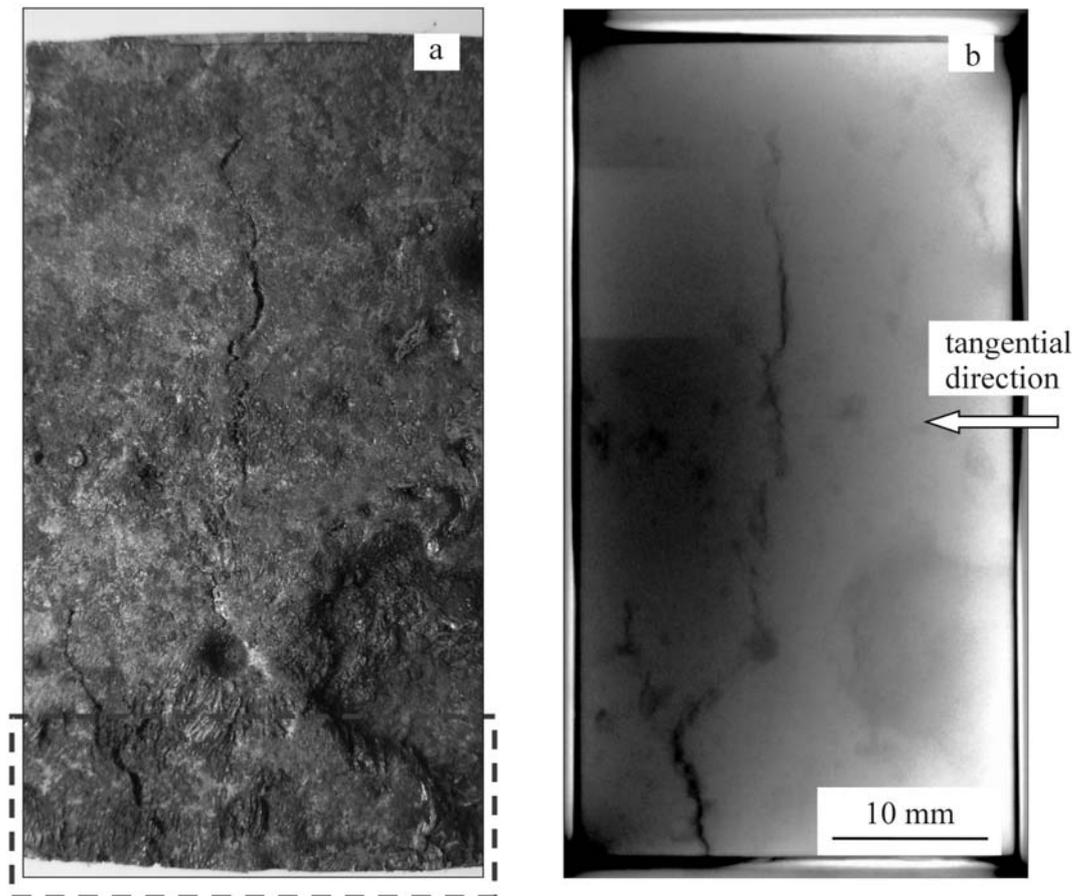
Fig. 9. a) Optical macrograph of the channel wall surface zone with two cracks from Fig. 8 after cutting. The box indicates a sample cut for subsequent fractography study; b) detail of radiographic image of this zone.

The zone with two cracks in box B was cut out of the insert wall and the cut surfaces were ground parallel. Optical macrograph of inner surface of the insert wall with the cracks is in Fig. 9a and the corresponding radiographic image is in Fig. 9b. The cracks in Fig. 9a appear to be separated but the radiographic image indicates that they are interconnected. They are oriented perpendicular to the surface and generally run along the insert channel despite some crack branching is possible in radial direction. Thus, these cracks are detectable in radial and axial directions. However, they are not visible in tangential direction even on relatively thin slice (see Fig. 10). Only the indications of large inclusions close to the inner surface of the channel are visible.

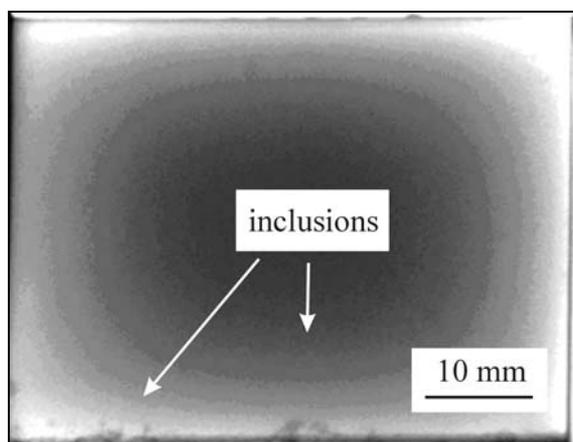
Fig. 10. Radiographic image of the segment from Fig. 9a in tangential direction.

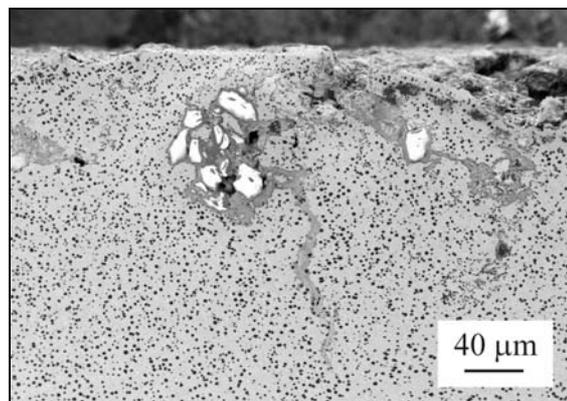
Fig. 11. The most common defects observed in the studied DCI were large inclusions and agglomerates near the surfaces of the insert channels. The other defects accompanying these agglomerates were oxidized zone, holes, cracks and surface roughness.

The largest and possibly the most typical casting defects in the studied material were large inclusions and their agglomerates (Fig. 11). They can easily be seen by a naked eye on the polished/etched surfaces. They are randomly distributed in material volume but their concentration significantly increases at the interfaces with the steel tubes. The size of the individual inclusions varies within wide range  $200\text{--}500\ \mu\text{m} \times 400\text{--}800\ \mu\text{m}$  but smaller and greater inclusions were also present. Their shapes vary from relatively regular, e.g. rectangular and/or hexagonal, up to highly irregular ones. The agglomerate size and shape depend on the number and arrangement of individual particles.

The inclusions are often surrounded by the affected zone and accompanied by crack-like features and holes. The inclusions are non-conductive non-metallic particles. Their EDX analysis and mapping revealed high concentrations of Mg, Si and O, whereas Fe was practically absent. The concentrations of Mg and Si in the surrounding affected areas were reduced compared to the particles themselves. Oxygen content

remained relatively high and Fe concentration significantly increased. Thus, the inclusions are Mg-silicate slag or dross particles and the surrounding zone is partially oxidized iron matrix. Because the inclusions were mostly found at the inner surfaces of the insert channels, they most probably originate from the sand used to fill steel tubes during casting.

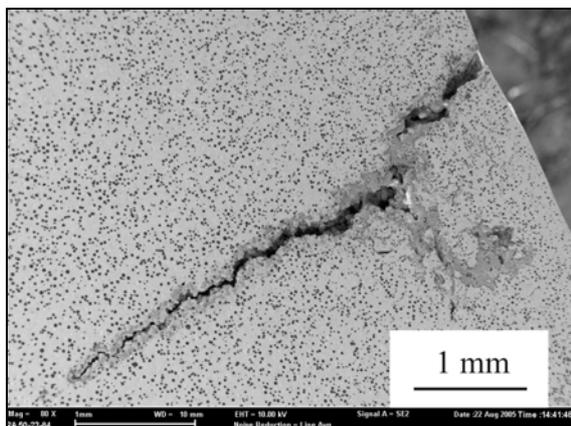
*Deformed mock-up:* The defects in the mock-up microstructure were identical to those in the as-produced material except cracks found in selected zone of the insert walls. The morphology of such cracks was investigated on side surface of the sample cut as indicated in Fig. 9a. Figure 12 is a small magnification micrograph of one of the cracks, which is around 10 mm long. This agrees well with the size indicated by other means. The fracture surfaces were corroded and it is difficult to exclude at least partial contribution of sample preparation procedure to this corrosion process. Large slag inclusion is directly connected with this crack but it does not seem to be the crack origin. Most probably, true fracture origin was another defect along the crack surface in either direction from the current section.

Fig. 12. A profile of the surface breaking crack in L1 mock-up wall (see Fig. 9).

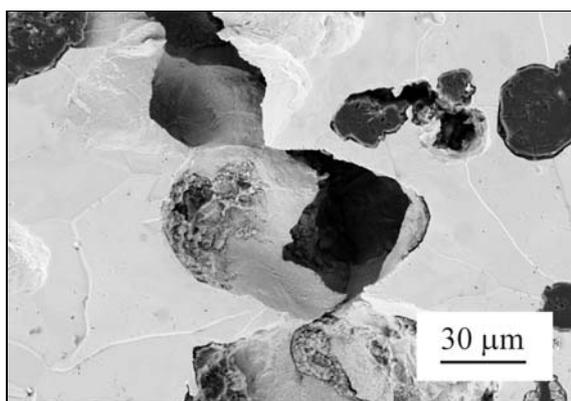
Figure 13 provides the information about the growth mechanism of such cracks. Distinctively different profiles of the crack lines on both sides of the crack with characteristic internal necking of the matrix ligaments indicate that the crack grew via gradual deformation and tearing of matrix necks among the nodules.

Fig. 13. Crack profile corresponds to typical ductile fracture morphology with intensive internal necking in the ligaments of the matrix among carbon nodules.
