# Ductile cast iron inserts for spent nuclear fuel disposal: radiography and fractography

F. Lofaj<sup>1,2\*</sup>, L. Metten<sup>1</sup>, A. van de Sande<sup>1</sup>, K.-F. Nilsson<sup>1</sup>, A. Eriksson<sup>1</sup>

<sup>1</sup>Joint Research Centre – EC, Institute for Energy, P.O. Box 2, 1755 ZG Petten, The Netherlands

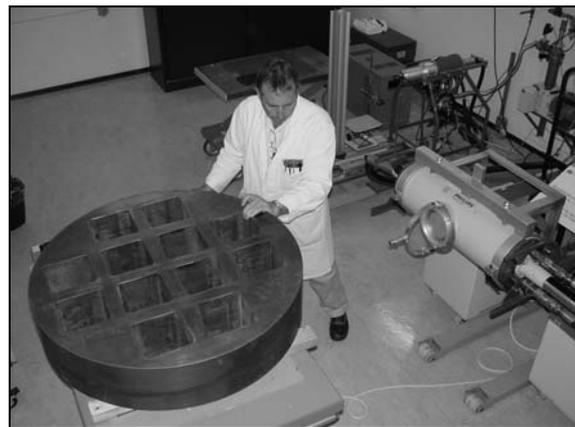
Fig. 2. Around 200 mm thick slab cut from the insert I26 and the setup for the radiographic inspection with the industrial 450 kV X-ray source. The sections that were cut from similar slabs for radiographic and microstructure investigations are indicated.

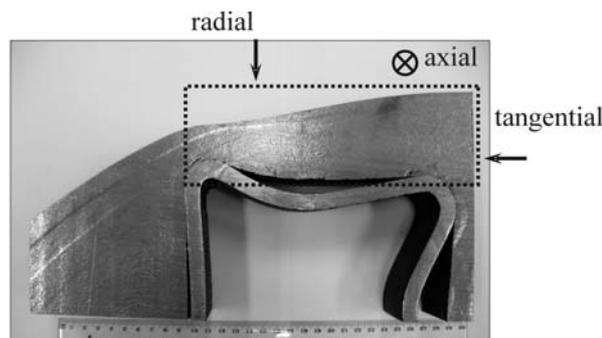
Fig. 3. A 50 mm thick part (designated L1) cut from 300 mm thick cross-section of the deformed mock-up with cracks, which was used for radiographic and microstructure studies. The directions of radiographic examination are indicated. The dotted box indicates the area shown in Fig. 8.

The segment L1 with the largest cracks was chosen for further study. An approximately 50 mm thick part with cracks (the box in Fig. 7) was cut from L1. The obtained segment is shown in Fig. 3 and the zone of outside wall in the box was studied in axial direction. Both top and bottom sides of this slice were subsequently ground to prevent overlapping of surface roughness with the internal defects. Figure 8 shows radiographic image of this piece in axial direction. Optical density of the films is approxim-

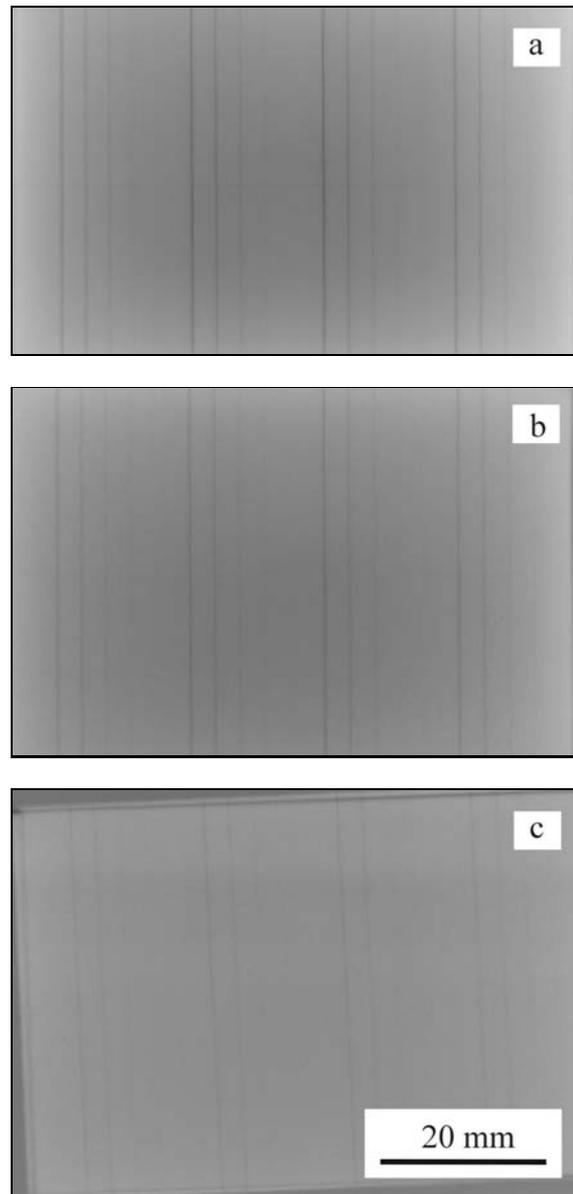
**IQI reference blocks:** Visibility and detectability tests in RB1 and RB2 blocks performed with the high resolution film Agfa Structurix D2 revealed that 100  $\mu\text{m}$  wide grooves, which are  $\geq 1.25$  mm deep and volumetric indications (holes) with the size  $\geq 0.4$  mm can be detected (Fig. 4a). In the case of the medium resolution Agfa Structurix D4 film, 100  $\mu\text{m}$  grooves with the depth  $\geq 2.5$  mm and volumetric defects with the size  $\geq 0.67$  mm were detectable (Fig. 4b). Maximum detectability of the low resolution film Agfa Curix blue HC-S Plus was  $\geq 5$  mm for 100  $\mu\text{m}$  grooves and  $\geq 0.8$  mm for volumetric defects (Fig. 4c).

Fig. 4. The comparison of detectability and visibility of the artificial cracks in IQI reference block RB1 using: a) high resolution Agfa Structurix D2 film; b) medium resolution Agfa Structurix D4 film; and c) low resolution film Agfa Curix blue HC-S Plus film.
